## RISK ANALYSIS OF CVRD FORCEMAIN ON BALMORAL BEACH

### DRAFT REPORT

Comox Valley Regional District

NHC Ref. NO. 3001937

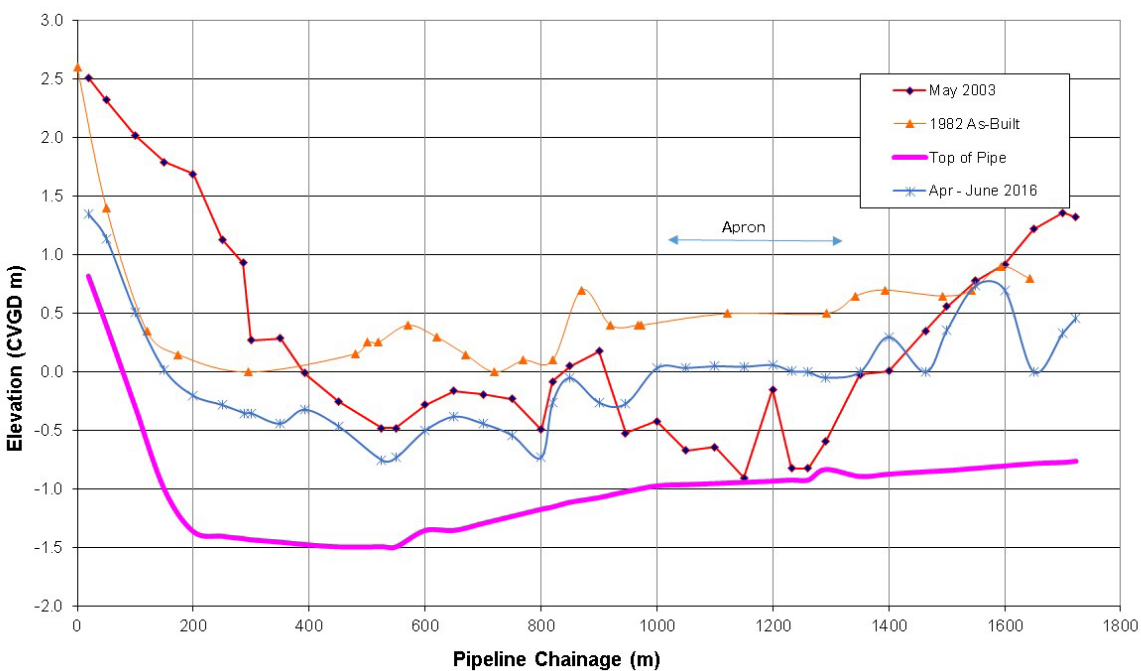
**Figure 8: Profile along forcemain and beach level in 1982, 2003 and 2016 (chainage is from south to north)**

Monitoring by the CVRD in 2003 indicated that the depth of cover over the forcemain was less than 0.5 m in some locations (Figure 8). In May 2003, inspections showed that portions of the line were exposed (Photo 5). The study concluded that the forcemain was vulnerable to scour and undermining due to long-term lowering of the beach profile and identified four alternatives to prevent a failure of the forcemain:

1. Re-locate the sewer line away from the foreshore.
2. Install a parallel section of line at a lower elevation to prevent undermining.
3. Install protection over the portion of the line that is threatened by scour.
4. Place a gravel and cobble berm over the line and install a series of groynes to retain the beach material.

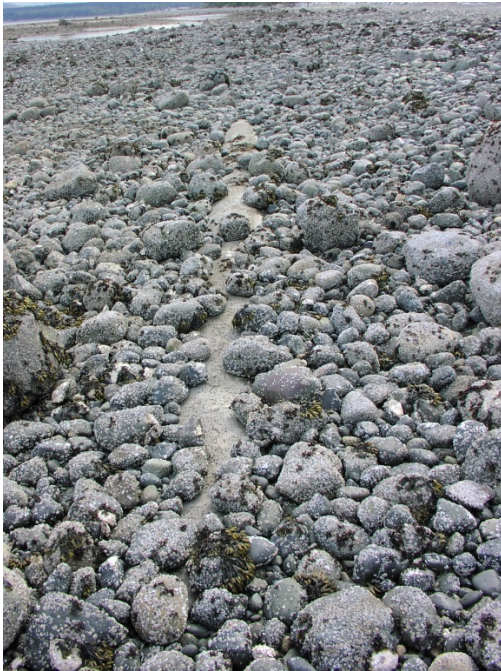
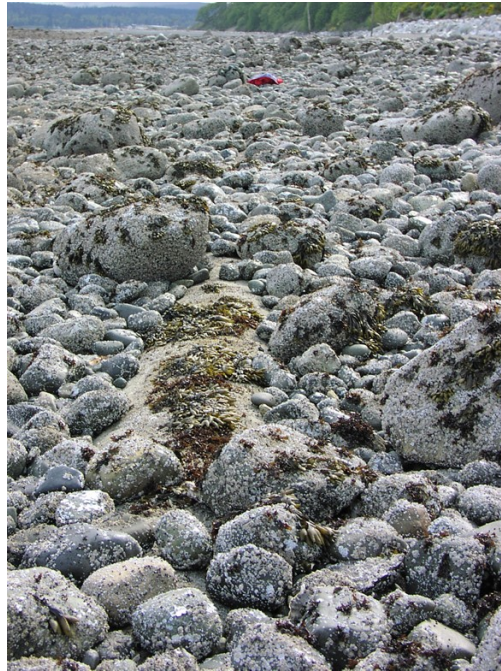
**Photo 5: Exposed sections of forcemain near Sta. 11+00 in May 2003**

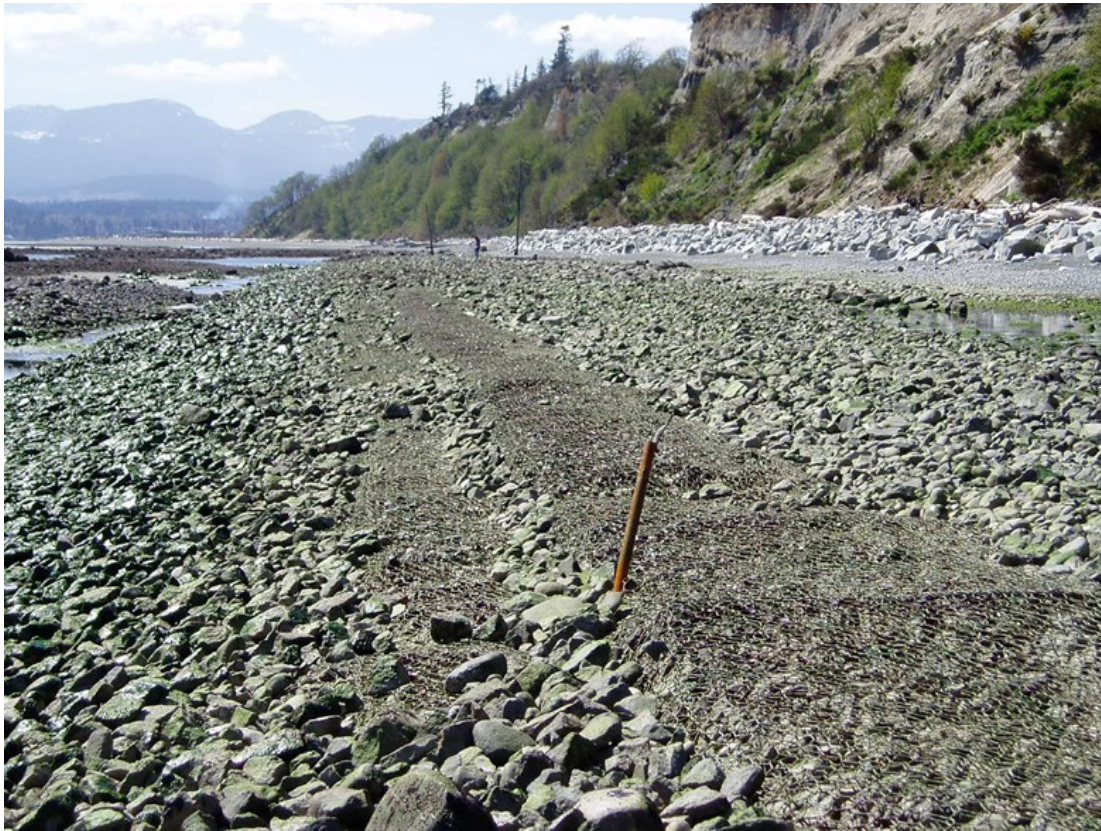
**Photo 6: Waves have removed cobble-boulder cover and deposited material landward (April 2004)**

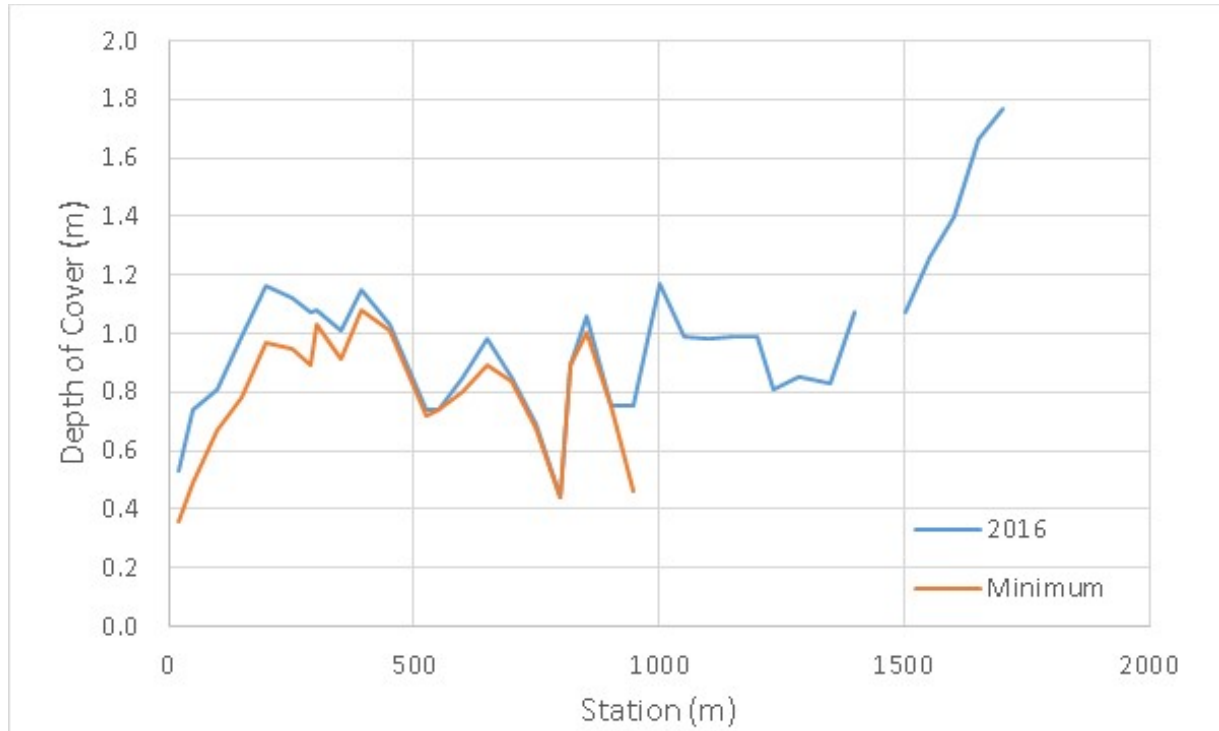
**Figure 13: Depth of cover over forcemain in 2016**

The northern end of the mattress protection is at Station 13+35. North of the mattress, Station 14+00 and 17+00, the depth of cover has remained greater than 1 m.

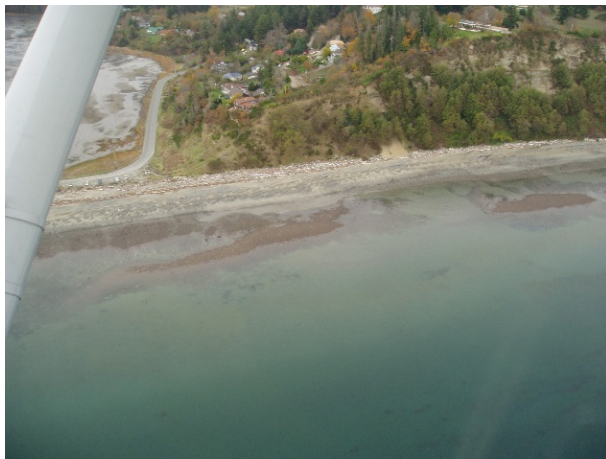
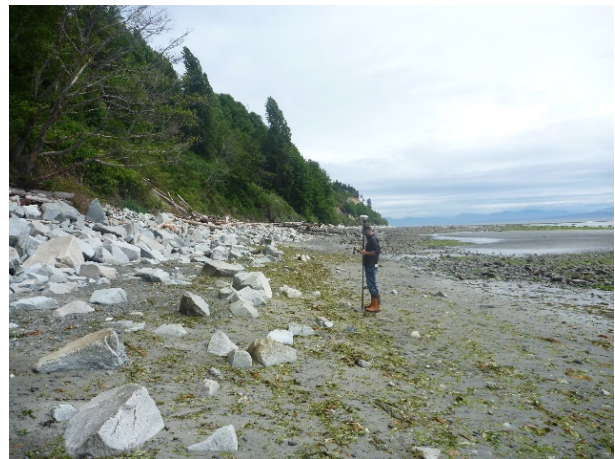
**Photo 7: Near Station 2+00 viewing north. Shoreline has been ripped since 2003. Riprap appears to have been displaced by waves onto beach**

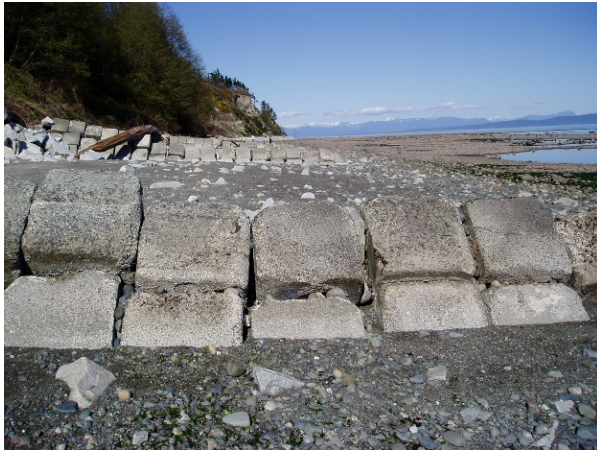
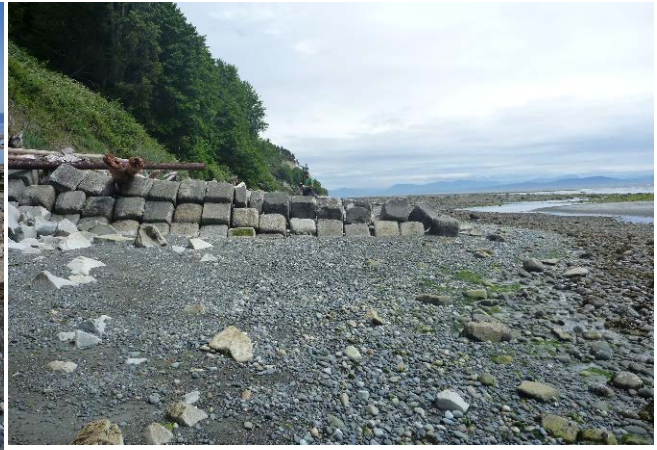
**Photo 8: Near Station 4+50, viewing north. Displaced riprap and concrete blocks on groynes**

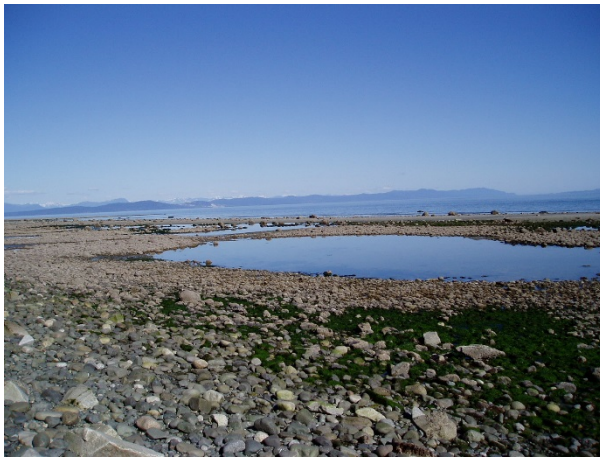
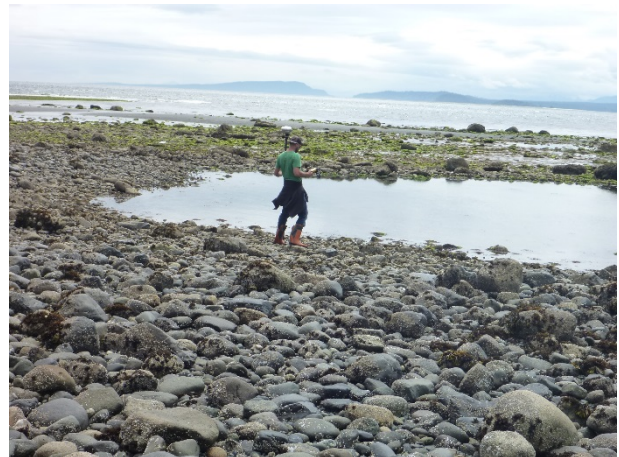
**Photo 9: Near Station 8+00 showing coarse-grained lower beach**

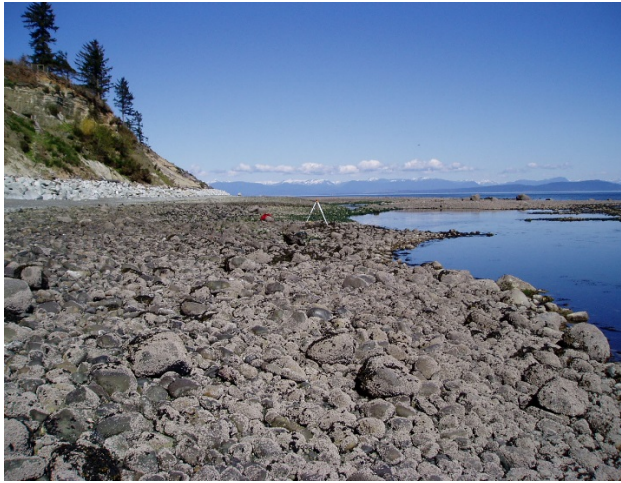
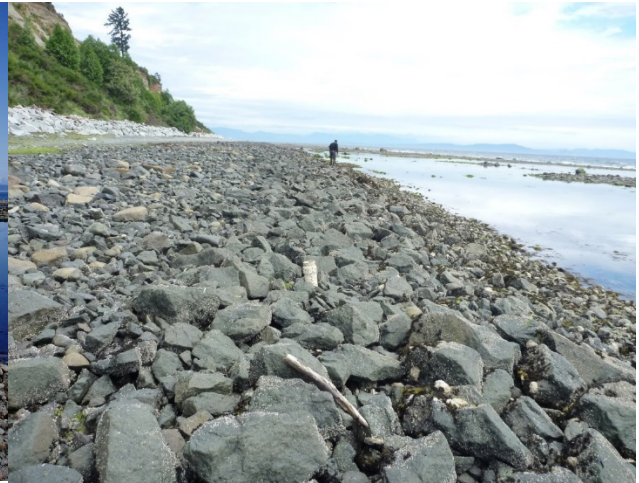
**Photo 10: Near Station 9+40, viewing north showing start of cobble/boulder protection over forcemain**

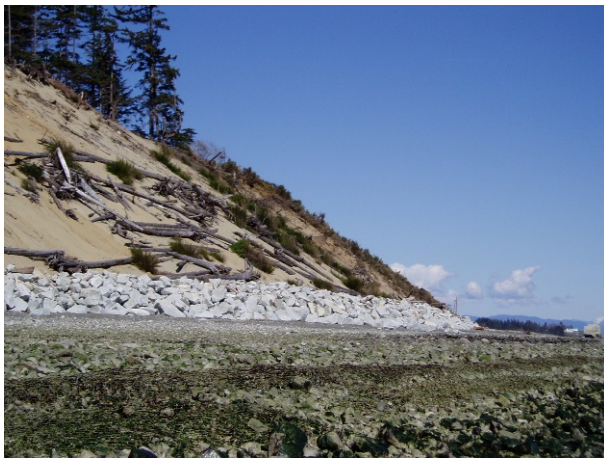
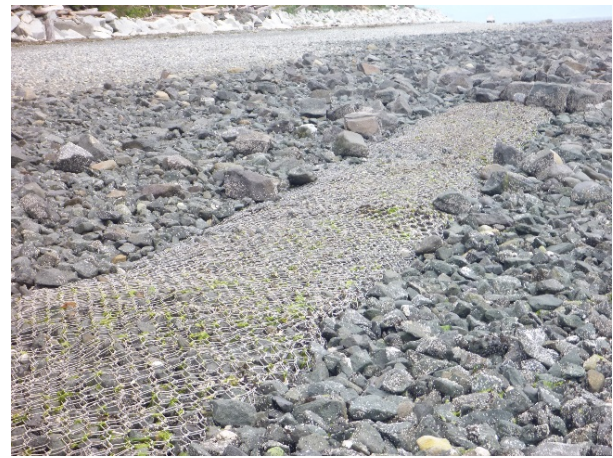
**Photo 11: Near Station 10+80 viewing north, showing exposed top of mattress**

- Monitoring and inspection of the beach should be carried out annually over the entire length of the forcemain on the beach (at present only the southern section is surveyed). A brief condition report should be prepared interpreting the survey data and the condition of the existing protection and indicating whether repairs or other work is required.
- Emergency response plans should be reviewed to deal with a potential breakage of the forcemain. This should include identifying and obtaining critical equipment that would be needed to repair a break.
- The top layer of the existing mattress that has experienced damage should be repaired.

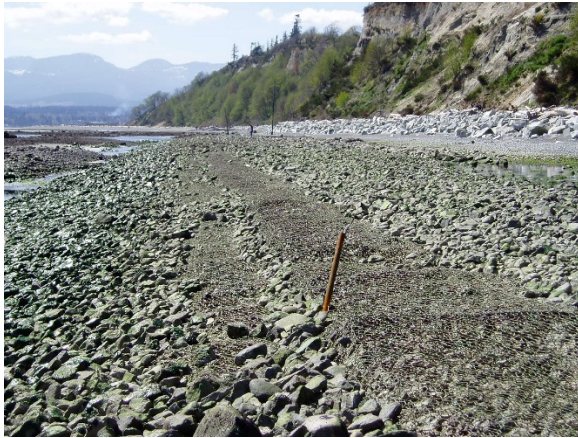
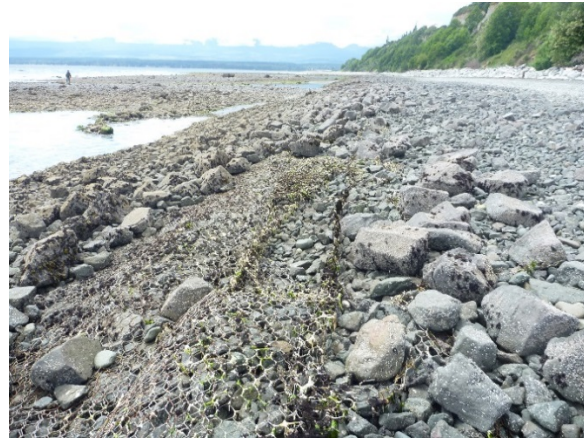
**Photo 12: Near Station 12+20 viewing southwest, showing exposed mattress and shoreward displacement of boulder/cobble cover**

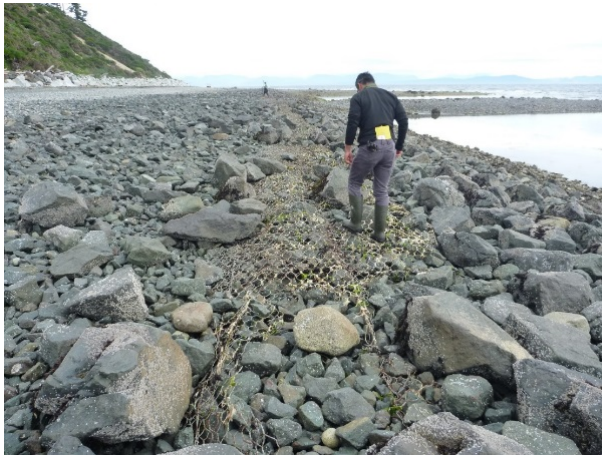
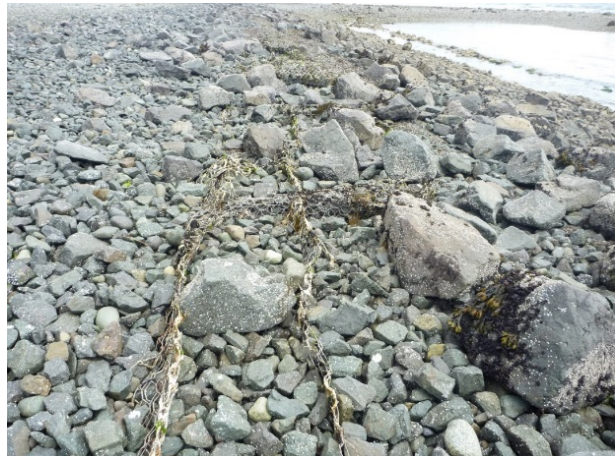
**Photo 13: Damaged top cover of mattress between Station 11+50 and Station 12+50, June 2016**
