Hornby Island Fire Department

Fire Hall Planning Report

December 7, 2004

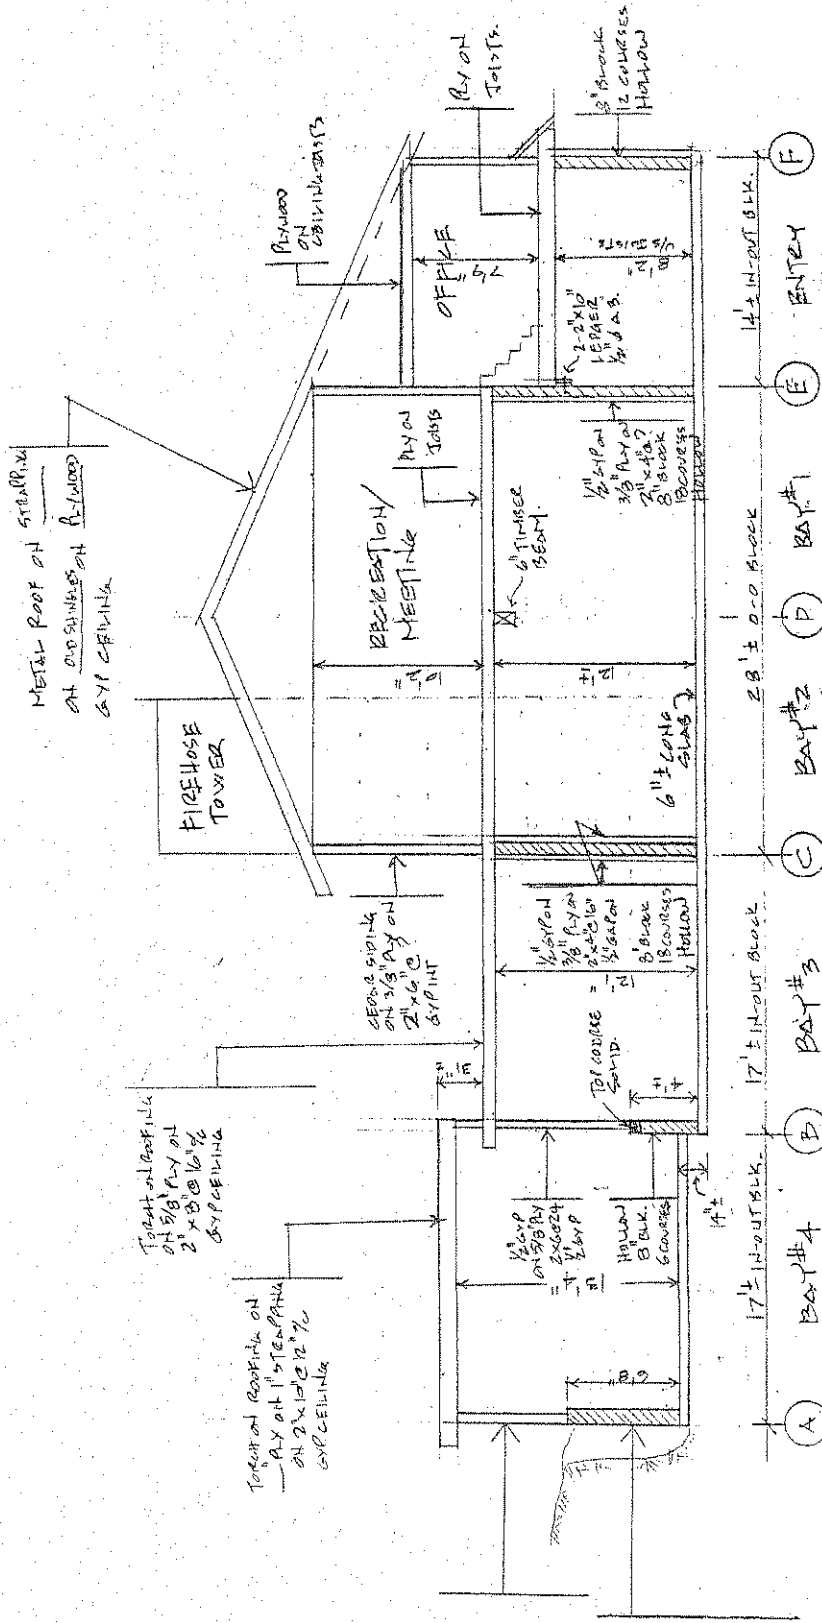
HORNBY ISLAND FIRE DEPT. (NOT TO SCALE)
SKETCH #1, BY: RM

- Center of rigidity of building as a whole is not close to center of gravity.
