MEMORANDUM

RE: Watercourse Assessment Results Summary at Maris Nature Park

Project
MARIS NATURE PARK

Title
WATERCOURSE MAPPING

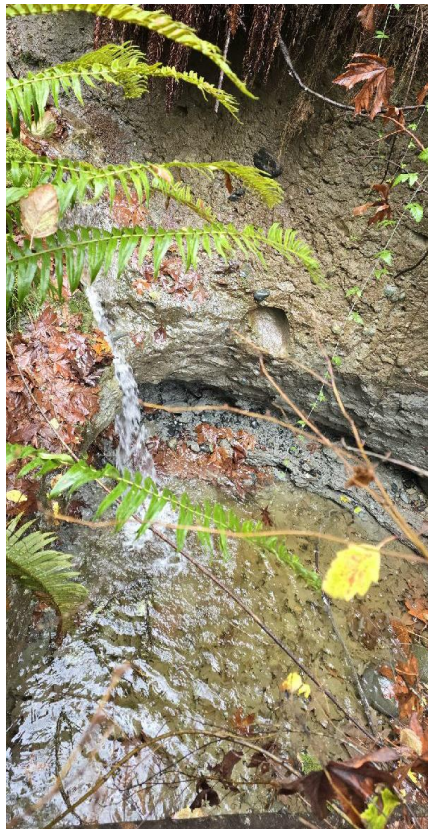
Photo 1: Confirmed fish barrier at the top of reach 2.

Three reaches were defined in the stream at the south end. Physical and habitat conditions of these reaches are provided in the tables below. The entire stream is assumed to be seasonal / ephemeral. Only the lowest break is likely to contain fish with the next break above likely being too steep (>20%) to allow fish access. The lowest reach is actually smaller than the reach above as a considerable amount of flow appears to infiltrate to the ground. The stream disappears just before the foreshore and is likely only connected to the marine environment during some combination of very high flows and high tide. There is a fish barrier approximately 185 m (1.2 m fall) upstream from the foreshore at the top of the second reach. The upper reach is therefore confirmed non-fish bearing.

Site:		Maris Nature Park		
<i>Stream ID:</i>	Un-named Stream	<i>Reach:</i>	2	
<i>Field UTM's</i>	Zone: 10U	354640E	5519034N	
<i>Site Length (m):</i>	120	<i>Left Bank Shape:</i>	Vertical	
<i>Mean Channel Width (m):</i>	2.0	<i>Right Bank Shape:</i>	Vertical	
<i>Mean Wetted Width (m):</i>	1.1	<i>Riparian Vegetation:</i>	Mixed Mature Forest	
<i>Mean Residual Pool Depth (cm):</i>	<5	<i>Crown Closure (%)</i>	20-40%	
<i>Bankfull Depth (m):</i>	1.0	<i>Cover:</i>	Moderate	
<i>Mean Gradient (%):</i>	26.5	<i>Dominant Substrate:</i>	Cobbles	
<i>Coupling:</i>	Coupled	<i>Sub-dominant Substrate:</i>	Gravels	
<i>Confinement:</i>	Confined	<i>D (cm):</i>	15	
<i>Morphology:</i>	Riffle Pool	<i>D95 (cm):</i>	35	
<i>Fish Status:</i>	Assumed Fish Bearing			
<i>Habitat Description:</i>				
Reach is within a steep confined gully. Ephemeral flows and steep gradient likely preclude access to fish. Habitat is marginal for rearing and spawning. Upper end of reach is a fish barrier.

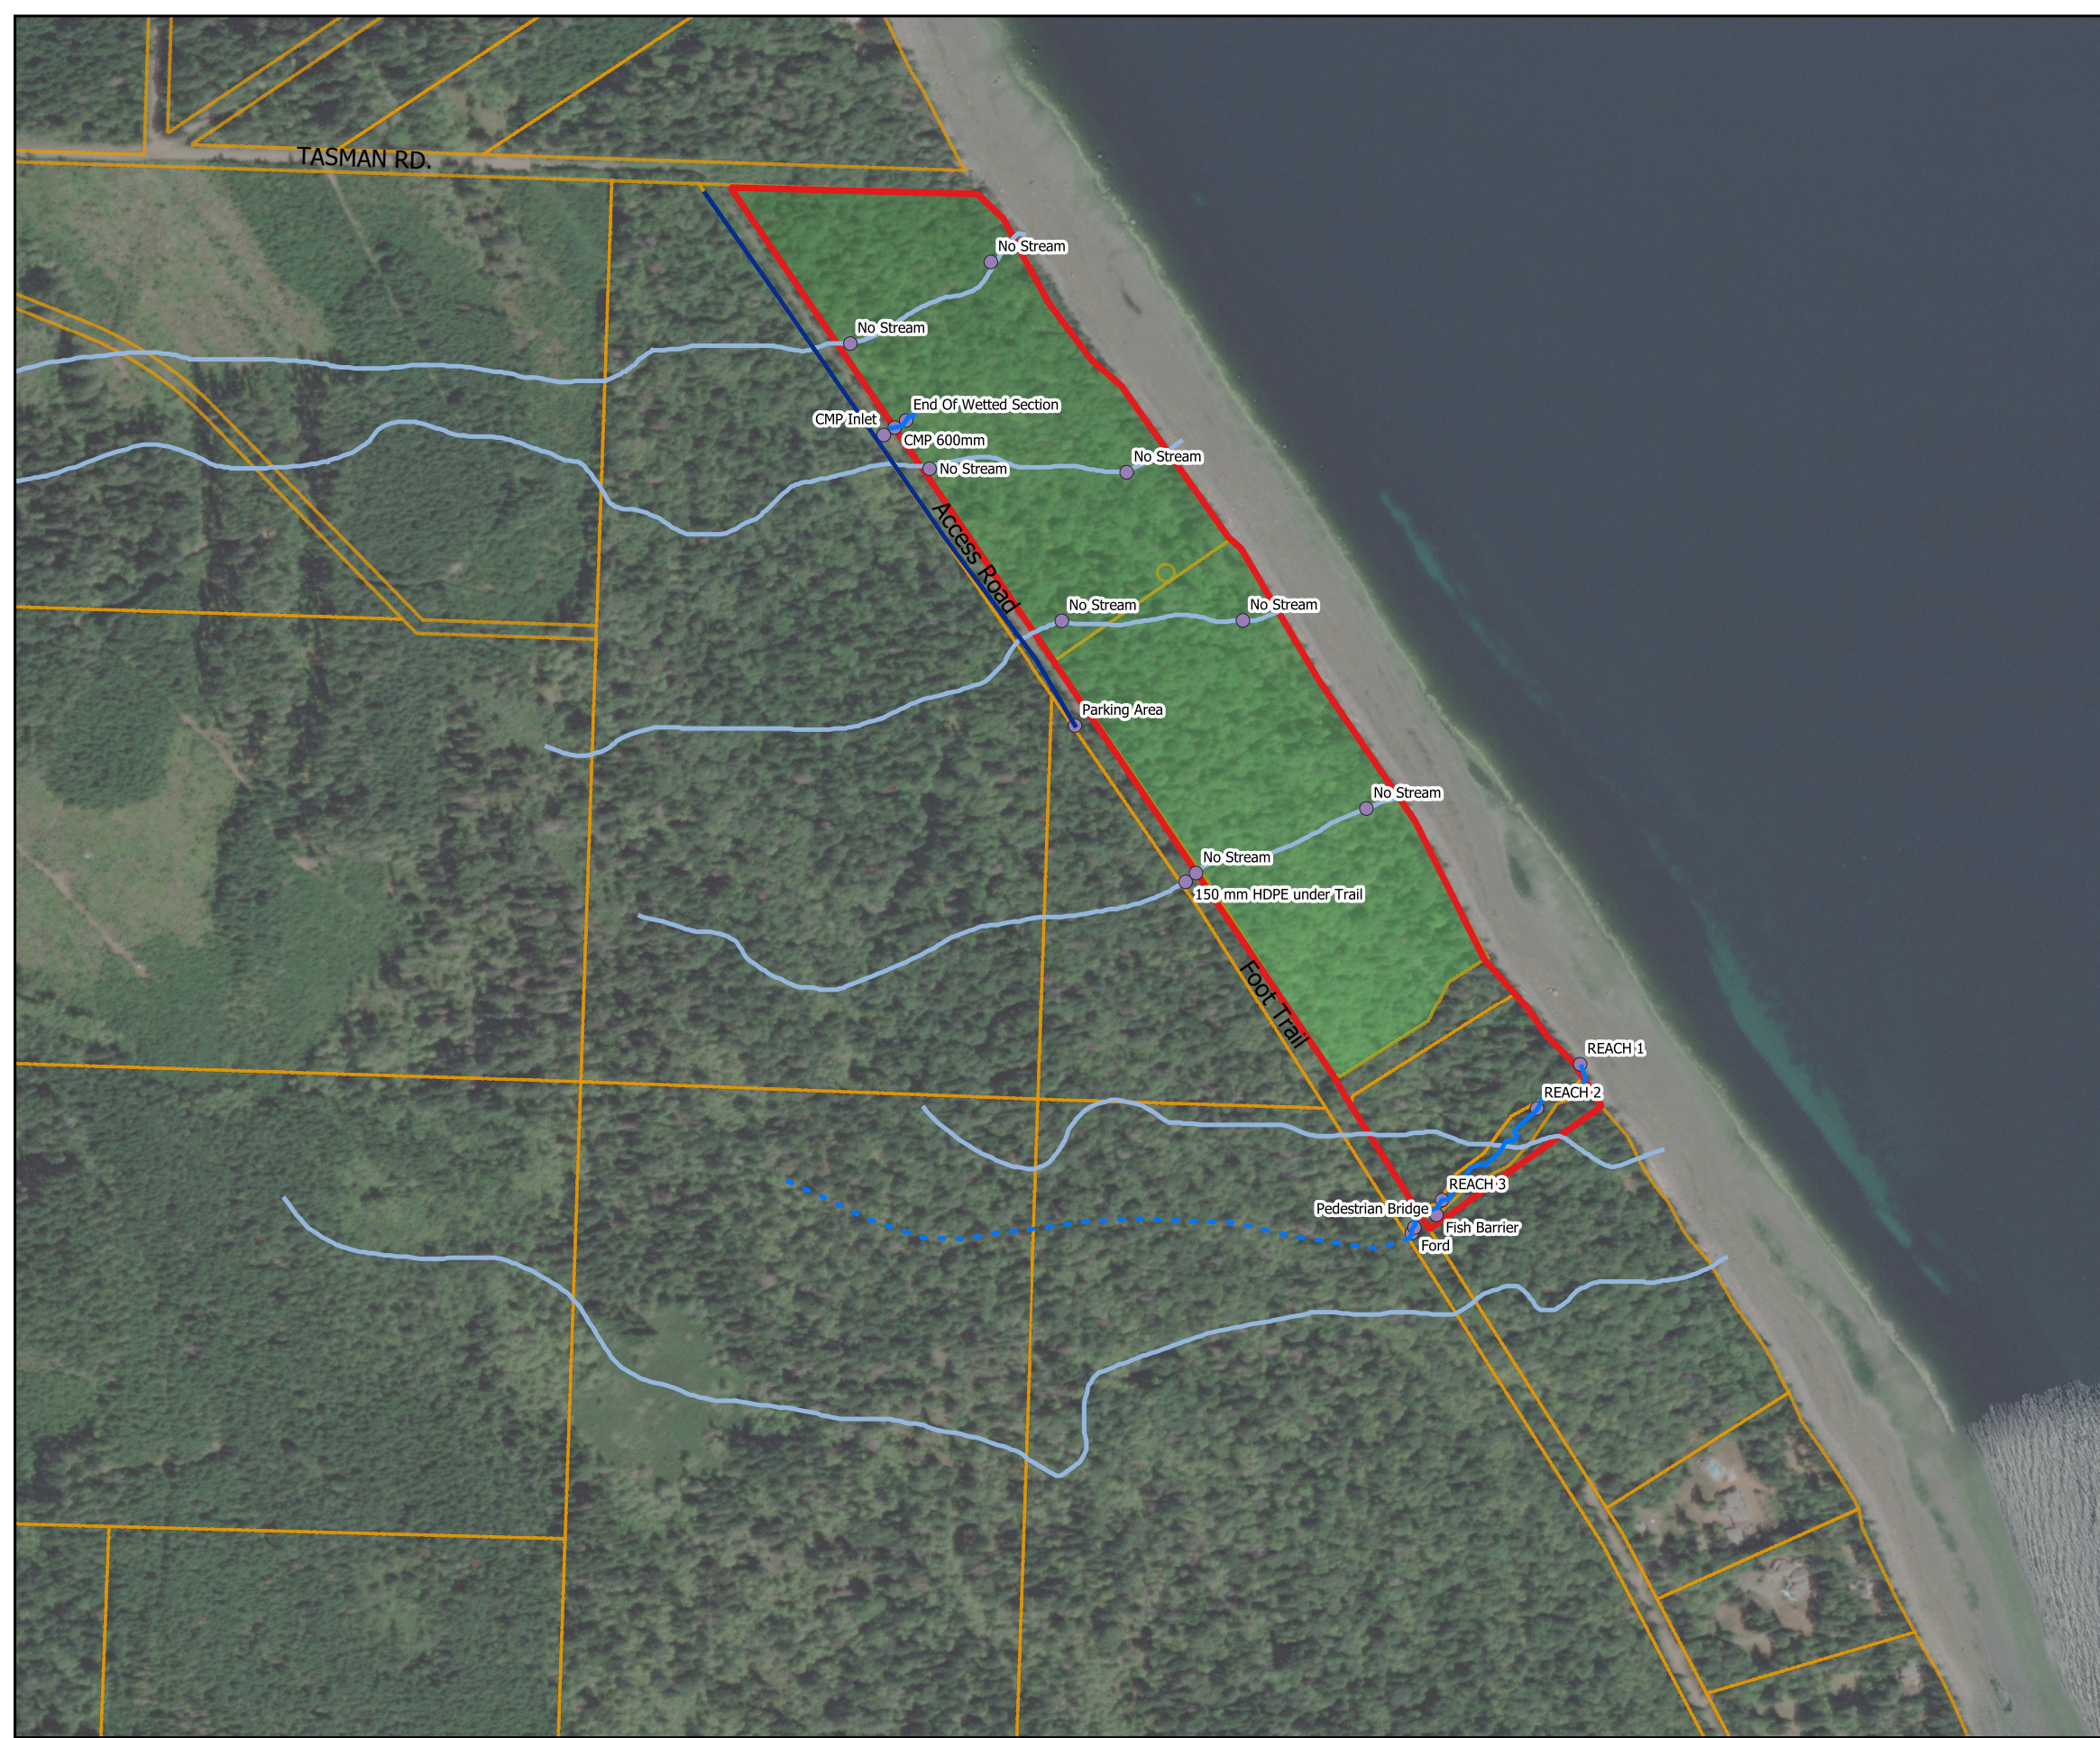
Drawn: BL 24-11-01	Scale: 1:6000
Checked:	PROJECT: 2024-056b
Approved:	FIGURE: 1

There is only one watercourse on the property along the southern boundary (Figure 1). There are a number of gullies, particularly at the north end, but none had any signs of scour and were determined not to be streams. There is one more stream feature where the road culvert concentrates flows but this dissipates and flows infiltrate to ground after approximately 50 m. There is no sign of this feature at the slope break.

The stream centerline above (light blue on Figure 1) has been inferred from aerial imagery but it is very difficult to make out given the tree canopy. The inferred section should not be used for decision making and should be reassessed on the ground with permission from the landowner.
