## RISK ANALYSIS OF CVRD FORCEMAIN ON BALMORAL BEACH

### DRAFT REPORT

Comox Valley Regional District

NHC Ref. NO. 3001937

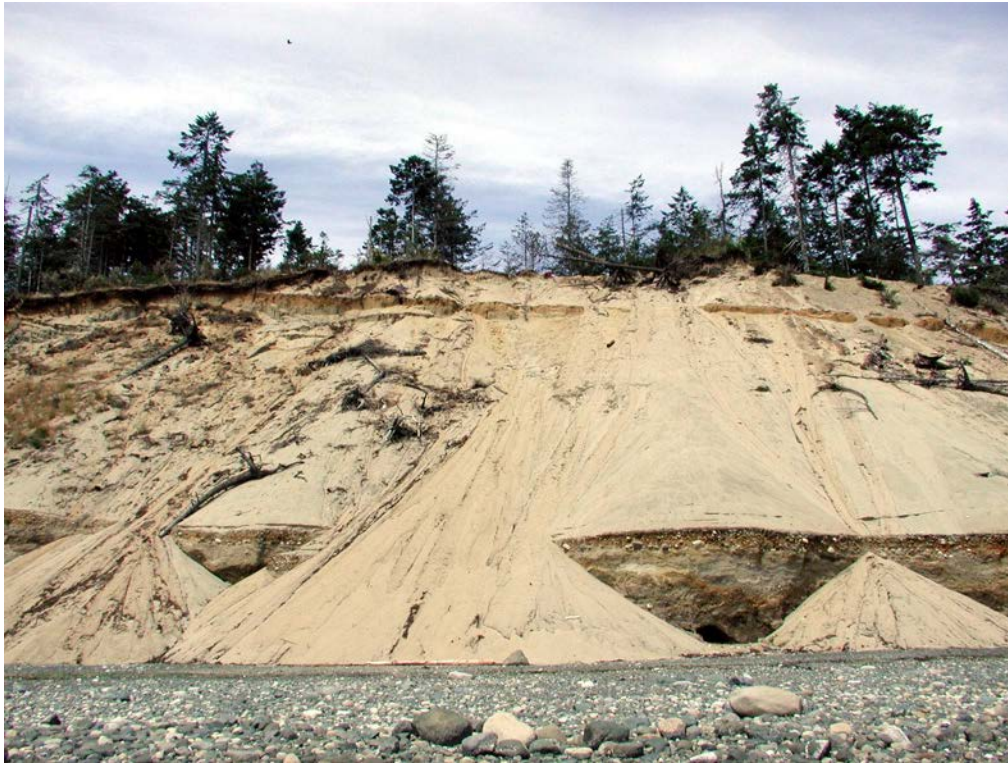
**Photo 1: Eroding Willemar Bluffs supplying sand and gravel sediment to Balmoral Beach, June 30, 2001**

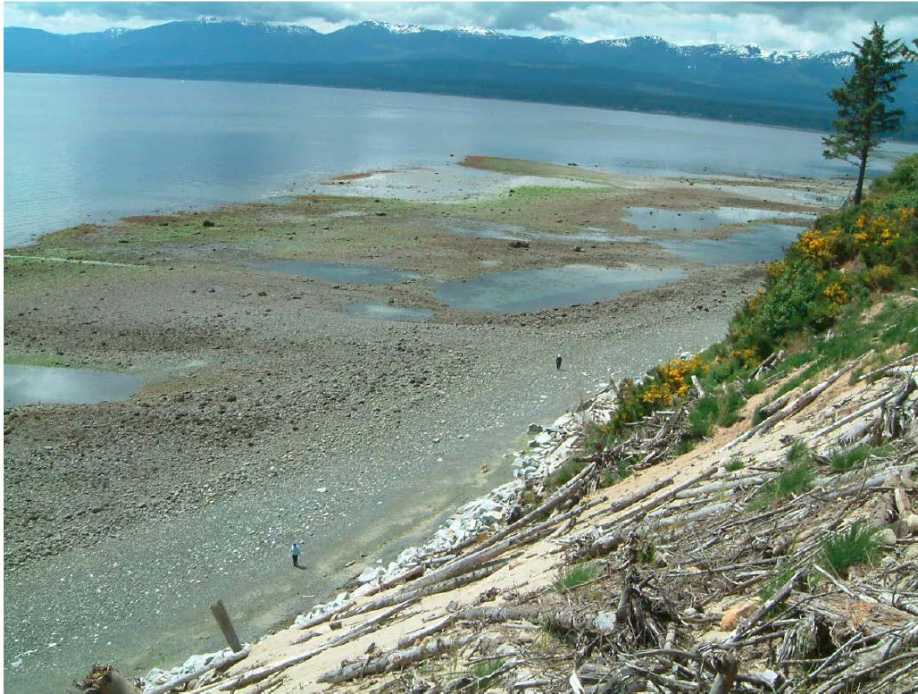
**Photo 2: New riprap along base of Willemar Bluffs with tidal pools in background, May 2003**

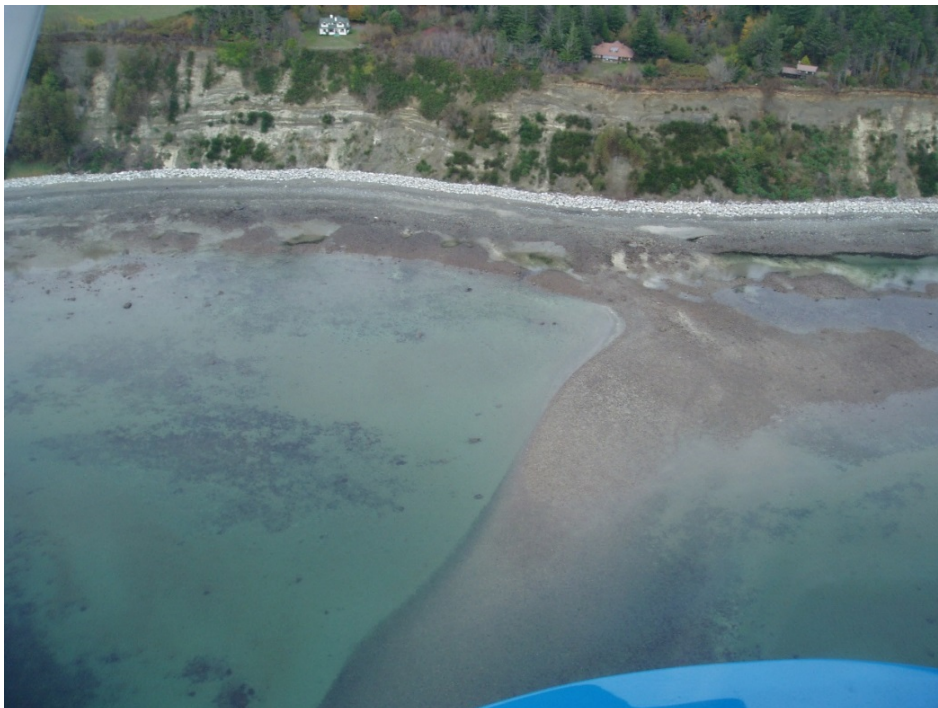
The main change to the beach since the study by Clague and Bornhold (1980) is that most of the bluffs are now continuously protected from wave erosion by riprap (Photo 2 through Photo 4), which has reduced the supply of sediment to the beach. It is our understanding that most of the riprap was constructed in the late 1990s and between 2001 and 2002. Groynes have also been constructed near the southern end, which reduces the sediment supply to Goose Spit.

**Photo 3: Continuous riprap along base of Willemar Bluffs, 2003**

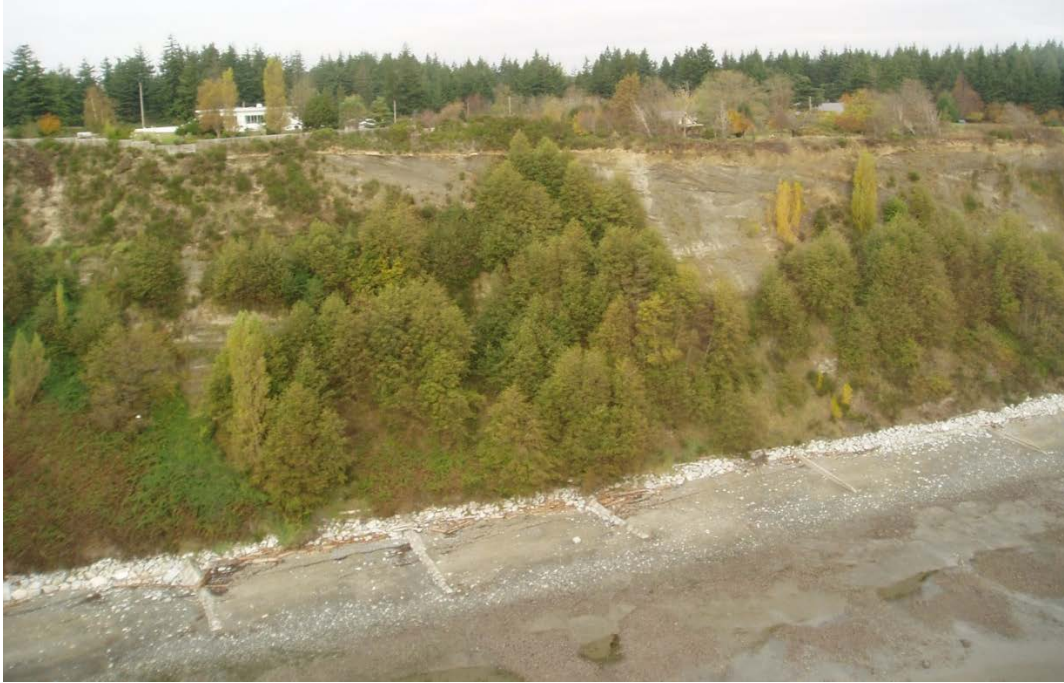
**Photo 4: Groynes and riprap at southern end of Balmoral Beach, 2003**

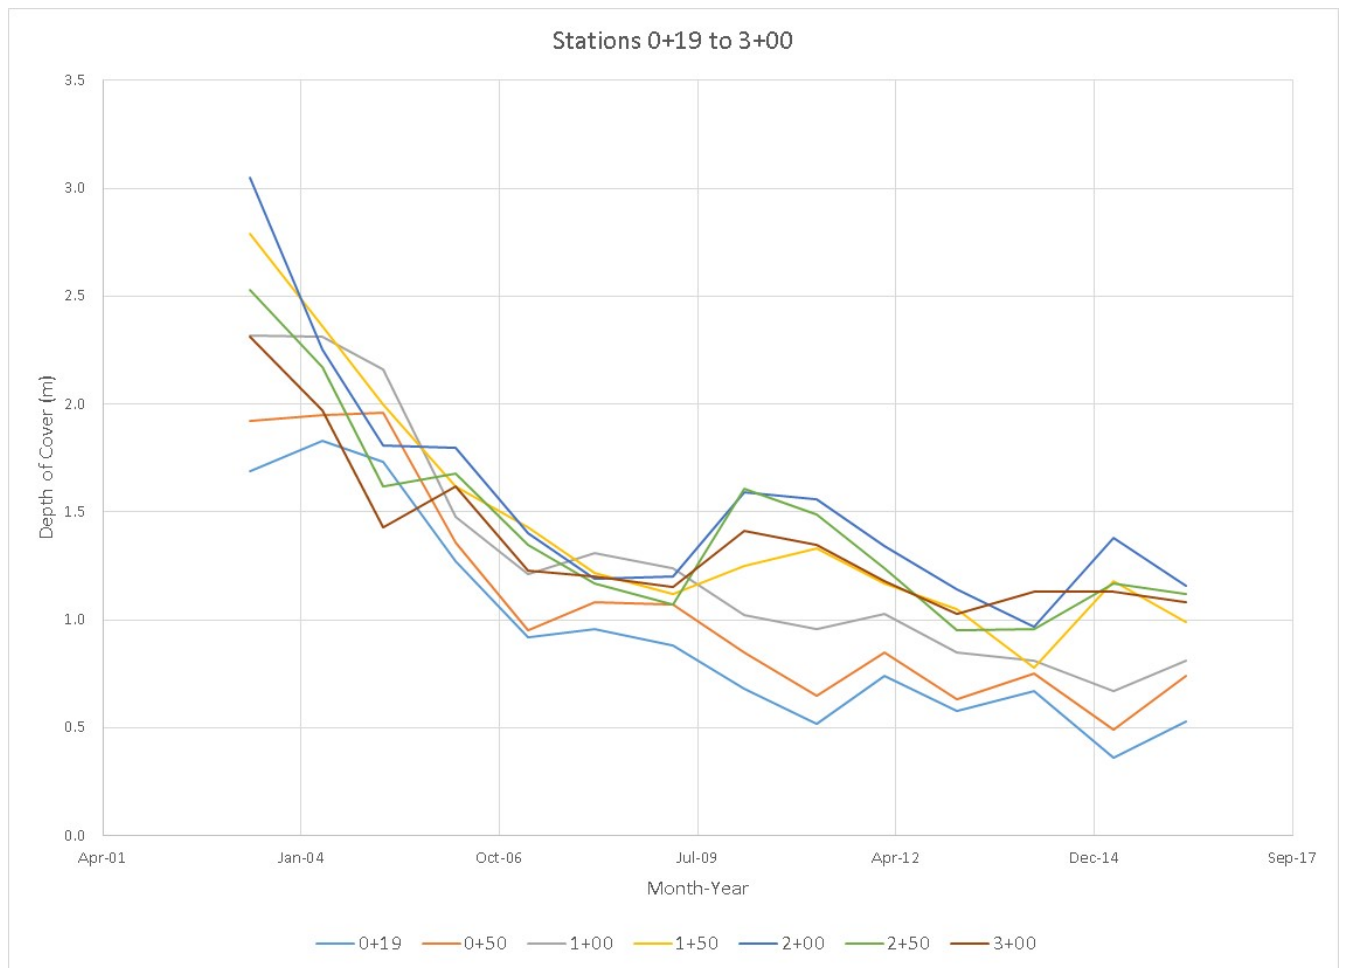
**Figure 10: Depth of cover over forcemain near southern end of Balmoral Beach from 2003 to 2016**

Trends over time are plotted in Figure 10 through Figure 12. Figure 13 shows the depth of cover along the forcemain in 2016 as well as the minimum depth of cover observed between 2003 and 2016.

For example, there appears to be a consistent relation between the installation of riprap along the base of the Willemar Bluffs and the lowering of the beach as documented in Figure 8 and Figure 10.

The second analysis used the data to define the rate of average bed lowering over time ( $S_i$ ). This rate of lowering has been highest along the section between Stations 0+19 and 4+50, although the rate appears to be slowing down over time (Figure 10). For future conditions, we assumed an average rate of -0.08 m/year between Stations 0+19 and 4+50 and a rate of -0.02 m/year between Stations 5+25 and 9+46. However, the rate of lowering is subject to considerable variation from year to year. For this analysis, yearly changes in beach elevation rates were binned from all surveyed points and a frequency histogram of profile changes was generated. Using these probabilities, a Monte Carlo simulation was performed to estimate the number of years before the beach level lowered to the point where the depth of cover was reduced to zero. It was assumed that the present depth of cover was 0.9 m along the forcemain. This analysis showed that the time for the forcemain to become exposed averaged 13 years under past trends in beach lowering. Note that future trends may differ from past trends, causing a longer or shorter time to pipe exposure. Also, this projection does not account for the effect of short-term fluctuations (year-to-year scour) due to storms.

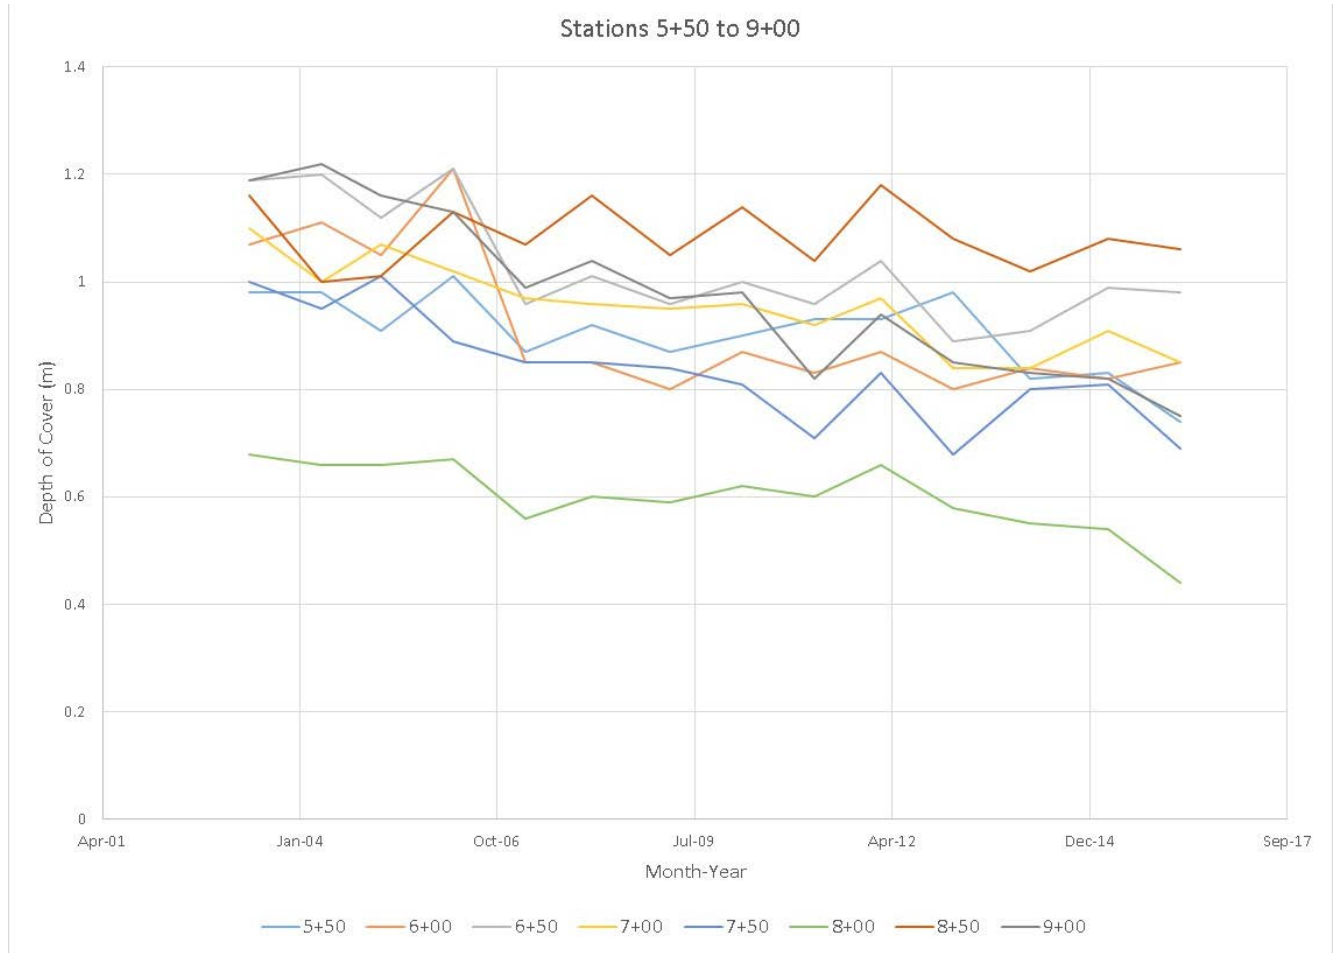
Figure 11: Depth of cover over forcemain in middle section of Balmoral Beach from 2003 to 2016

Figure 11 shows the depth of cover has remained between 0.8 m and 1.2 m at most locations along the middle section between Station 5+52 to 9+46. There appears to be a slow trend of decreasing cover over time (typically -0.015 m/year) at most locations. The lowest depth of cover occurred near Station

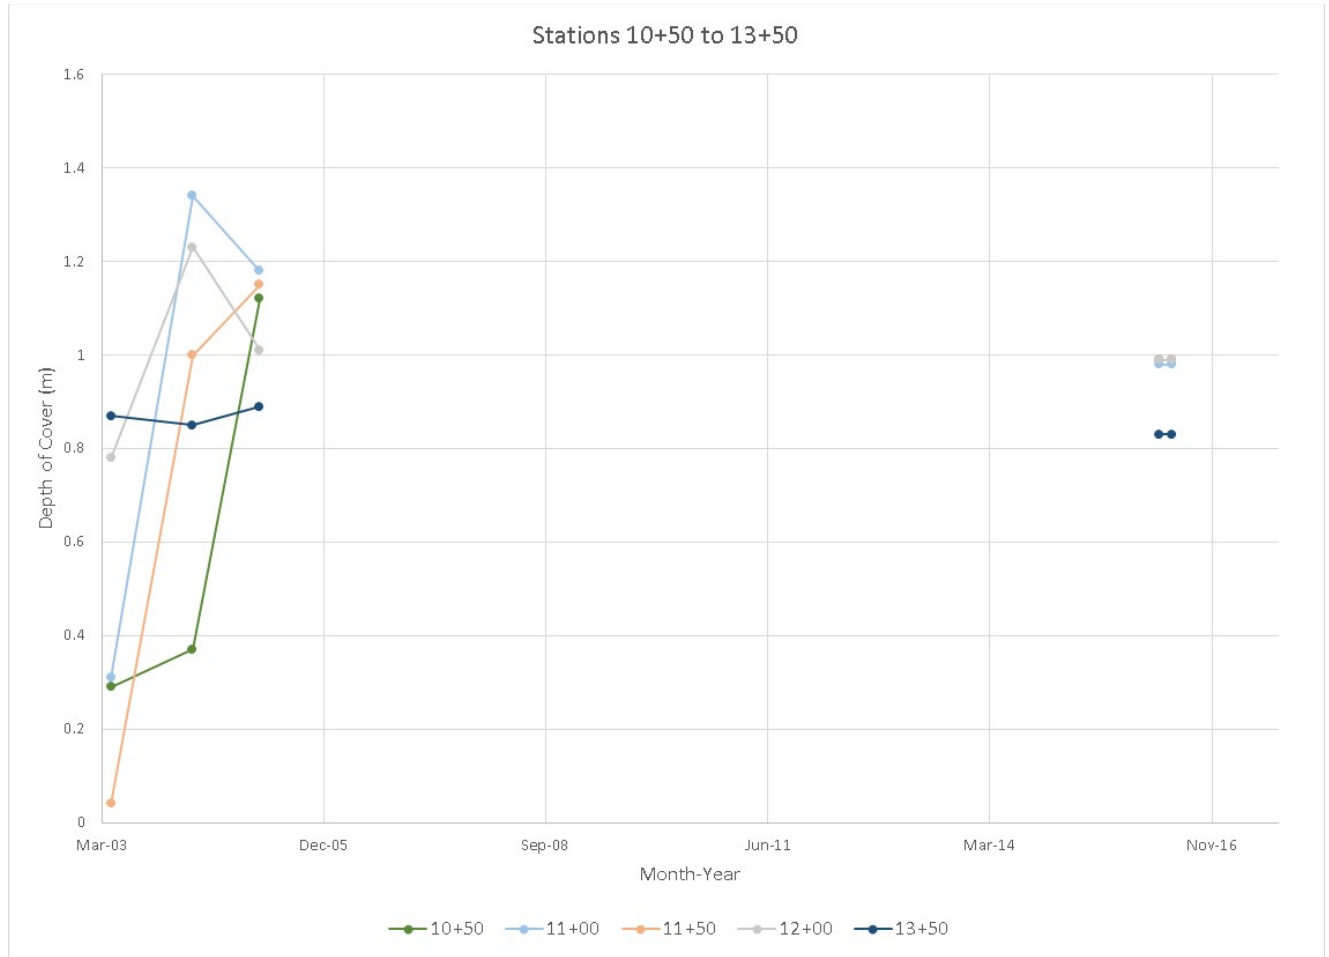
**Figure 12: Depth of cover over forcemain along section covered by mattress from 2003 to 2016**

Figure 12 shows the depth of cover over the forcemain has remained between 0.8 m and 1.0 m after the mattress protection was installed. The reduction in the cover at some stations (11+00) reflects the erosion of the cobble/boulder cover layer that was placed over the mattress (Photo 6).

The northern end of the mattress protection is at Station 13+35. North of the mattress, Station 14+00 and 17+00, the depth of cover has remained greater than 1 m.

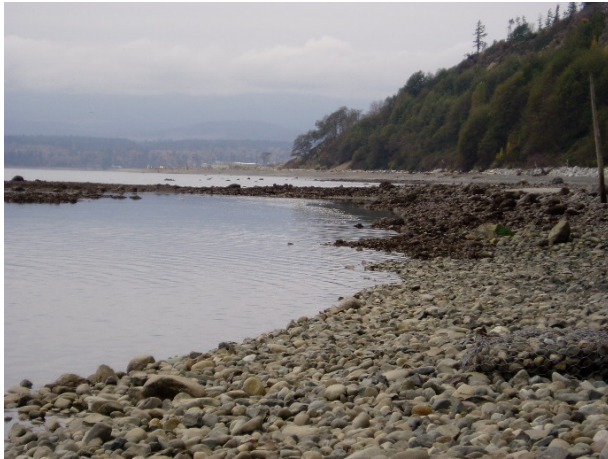
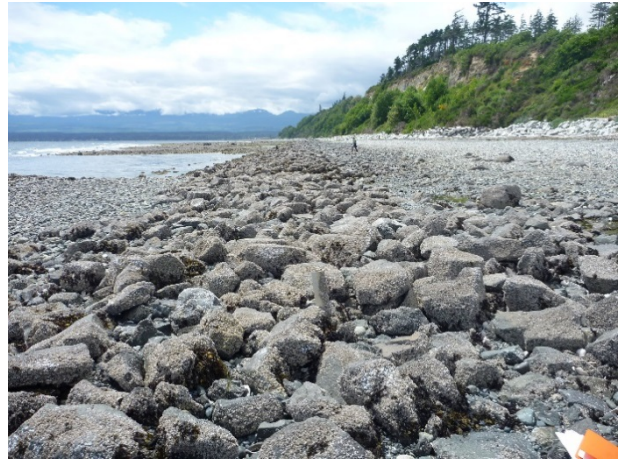
**Photo 14: Near Station 13+00, viewing southwest along intact boulder/cobble cover over forcemain**

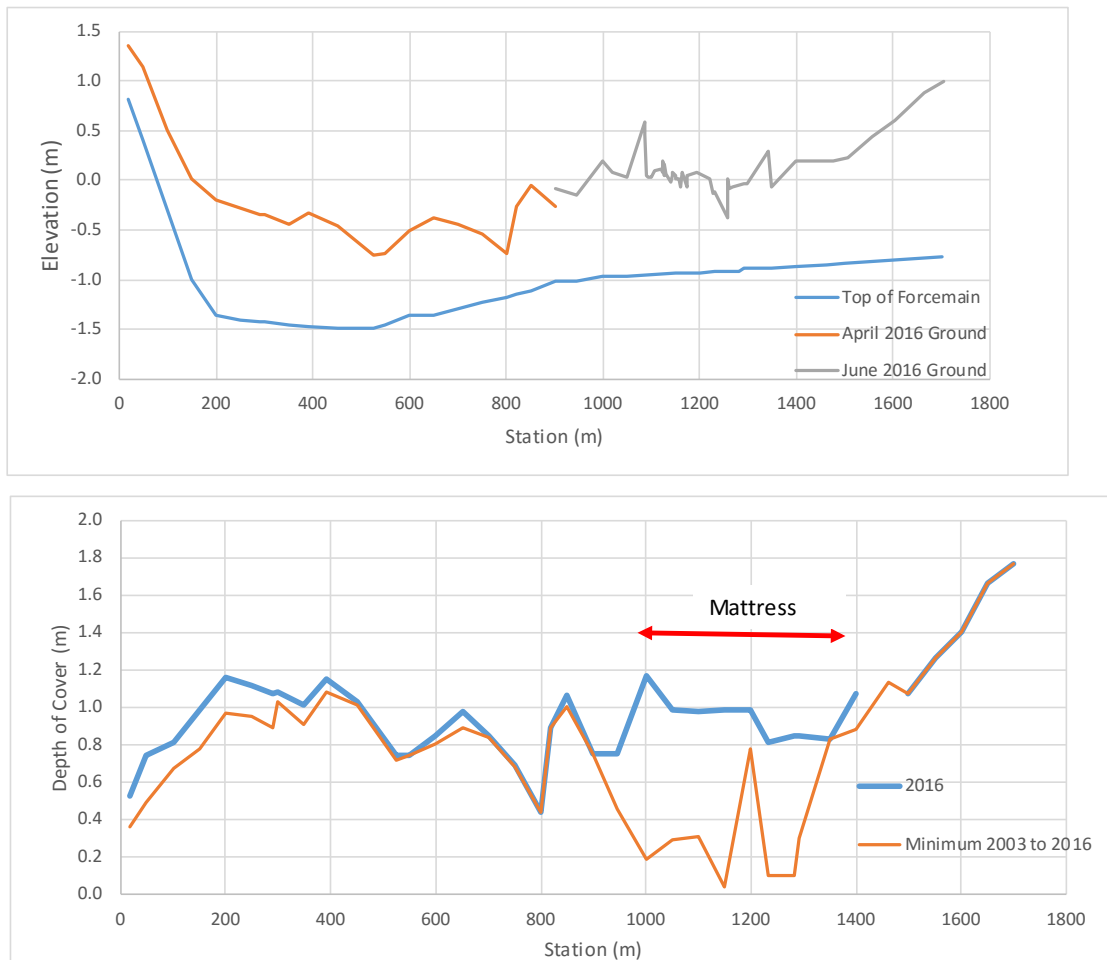
**Figure 14: Beach topography along forcemain (top) and present depth of cover (bottom)**

Figure 14 (top) shows the present (2016) ground profile along the forcemain and the top of the pipe (based on information from Associated Engineering 2003). The bottom plot shows the corresponding depth of cover over the pipe in 2016 as well as the recorded minimum cover over the period between May 2003 (prior to conducting the emergency repairs) and June 2016. The vulnerability of the forcemain to scour varies along the beach and is governed by several factors including:

- 0.5 m to 1.1 m near the south end (Station 0+00 to 5+00);
- 0.8 m in the middle section (Station 5+00 to 10+00);
- 0.8 to 1.0 m in the section by the mattress (between Station 10+00 and 13+50) and
- Greater than 1 m at the northern section (north of Station 13+50).

The low depth of cover near the south end reflects the rise in the level of the pipe as it approaches the manhole in Goose Spit Park. The depth of cover has remained near 1 m between Station 2+00 and 4+50 where the pipe is at its lowest level (El. -1.5 m CGVD). The depth of cover decreases north of Station 4+50 where the pipe starts to rise and the level of the beach drops off. The minimum cover in 2016 was 0.4 m near Station 8+00. The mattress protection between Station 10+00 and 13+50 has maintained the depth of cover at approximately 0.8 to 1.0 m since 2003.

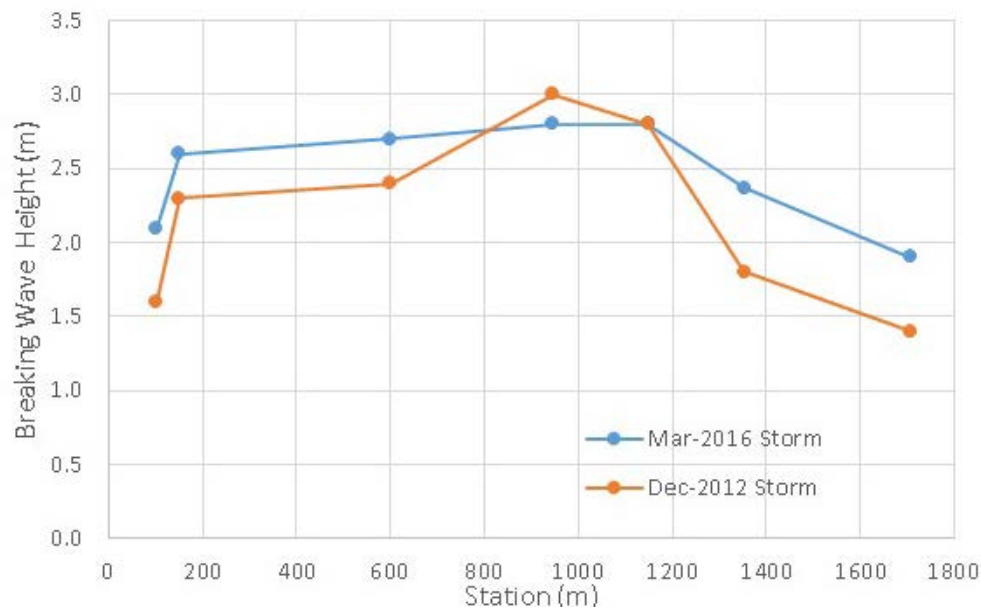
**Figure 15: Variation in breaking wave height over forcemain along Balmoral Beach for two storm events**

Figure 15 shows the variation in breaker height along the forcemain for the December 2012 storm and March 2016 storm. The incident deep water wave heights were 3.0 m for the 2012 event and 2.6 m for the 2016 event (Table 2). The variation in wave height over the forcemain is governed mainly by the variation in water depth and offshore beach slope, which affect the maximum breaker height ( $H_b$ ). This plot shows that the most severe wave conditions occurred between Station 9+00 and 12+00, which corresponds to the section, that became exposed in 2002 and the site of the 2003 emergency protection works. This section has the highest breaking wave conditions because the ground level is generally lower (water depth is greater) and the offshore beach slope is steeper than at other sections.

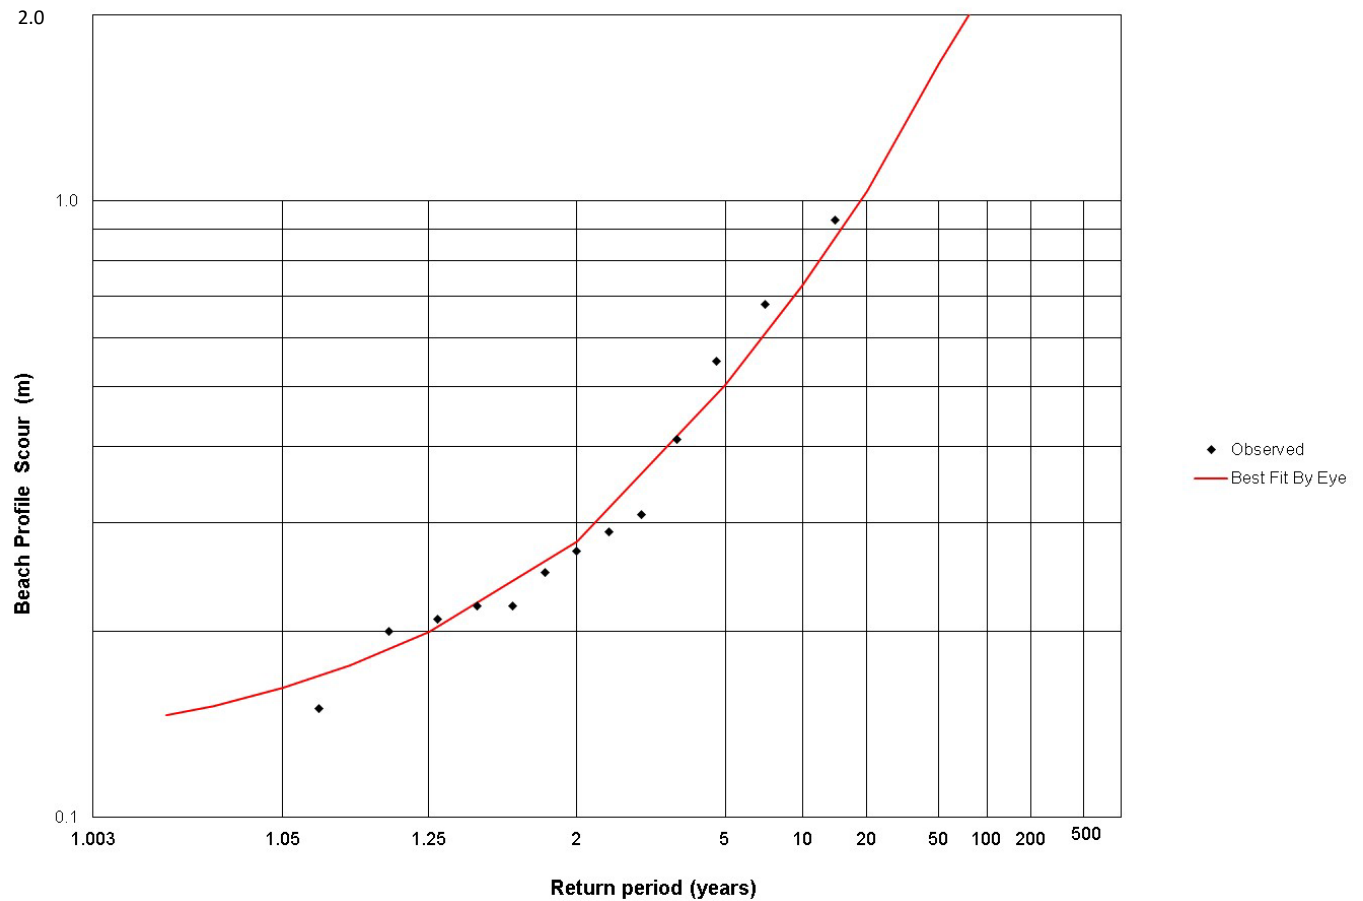
**Figure 16: Empirical estimation of probability of scour on Balmoral Beach at forcemain based on observed annual maximum beach level change from 2003 to 2016**

- The annual beach change (scour or infill) was computed between successive survey years for all profile stations (typically 22 points between Station 0+19 and 9+46).
- The annual maximum bed change (scour) was then compiled from this data, resulting in 13 values of annual maximum scour within the unprotected length of the forcemain.
- The scour values were then ranked from highest to lowest and assigned a frequency of occurrence of  $r/(n+1)$ , where  $r$  is the rank and  $n$  is the total number of years of observations.
- The points were then plotted as a cumulative frequency distribution and a smooth curve was plotted by eye through the data (Figure 16).

The plot in Figure 16 shows the return period (1/probability) of the scour equaling or exceeding a given magnitude in any one year. Some representative statistics are summarized in Table 6.

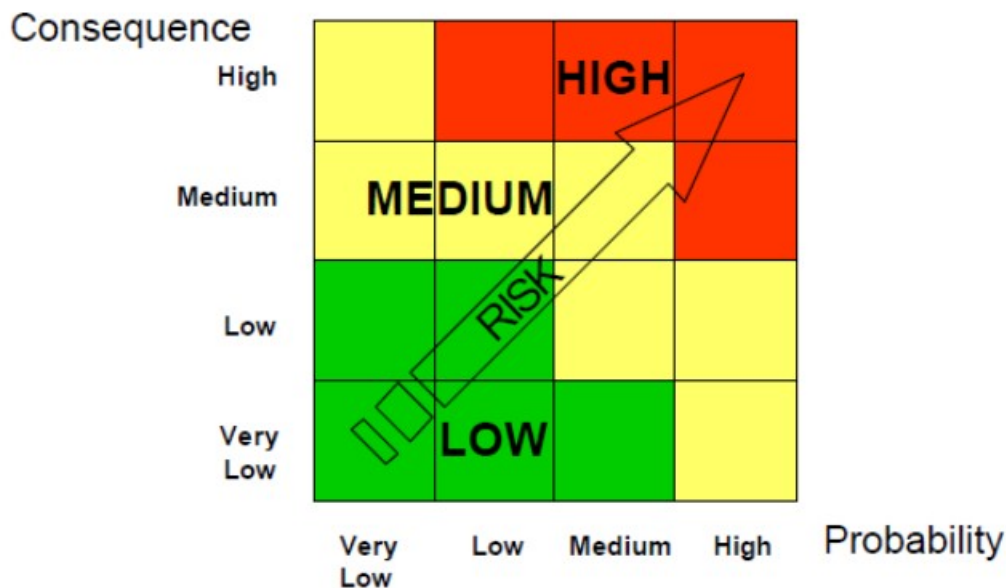
**Figure 23: Comparison of consequences and hazard probability to define risks**

Figure 23 shows a generalized representation of the relation between hazard probability, consequence and the resulting risk. The plot represents the following situations:

- There is a high probability (approximately 90%) that the depth of cover over the unprotected portion of the forcemain will be reduced to unacceptable levels (less than 0.3 m) during the next five years. Assuming emergency repairs are carried out in a timely manner this would be a low consequence event (Scenario 1), resulting in a cost of approximately \$600,000 per event. It is expected that these types of events will be recurring. This situation is classified in Figure 23 as a “medium” risk.
- There is a medium probability (roughly 50%) that a high consequence event (Scenario 2 involving a failure and a discharge on the beach lasting 24 hours) will occur at least once over the next 5 years. The approximate costs associated with this event are expected to be in the order of \$2 to 3 million per event. This situation is classified in Figure 23 as a “high” risk.

- There is a low probability (approximately 10 %) that a more severe consequence event (multiple failures along the forcemain and a wastewater discharge duration lasting more than 24 hours) will occur at least once during the next five years. This situation is also classified in Figure 23 as a “high” risk situation.
